RESAWN TIMBER CO. FIRE TEST REPORT

SFM 12-7A-1 TESTING ON EXTERIOR WALL ASSEMBLY CONTAINING T&G ABODO WOOD CLADDING INSTALLED IN THE VERTICAL ORIENTATION

K5893.04-121-24-R0

TEST REPORT FOR RESAWN TIMBER CO.

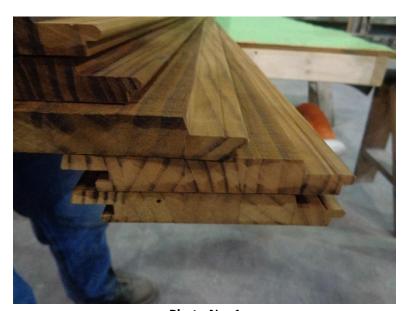
Photo No. 1 Exterior Cladding Profile

T&G Abodo Wood Cladding boards were used as the exterior cladding. The siding planks were mounted in a vertical orientation with the long dimension parallel with the framing members. The siding planks were 5-5/8 in. x3/4 in. thick x 8 ft. long. The planks utilized a tongue and groove that when installed created a 3/8 in. joint between the next plank that is installed. The planks were secured to the assembly using a #7 stainless steel wood screw placed on 16 in. centers.

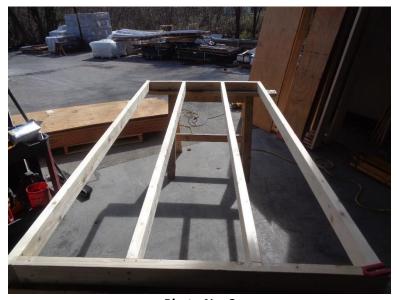
Photo No. 2 Framing Complete

Dimensional lumber measuring a nominal 2 in. x 4 in. x 96 in. long were uses as the framing "studs" of the assembly. These framing pieces were placed on 16 in. centers. The same size of framing pieces was cut to 48 in. long as used as a header and sill piece. These pieces were nailed to each stud framing piece using a 3-1/2 in. long 8d nail. The wood components used for the assembly framing were verified to have less than a 12% moisture content.

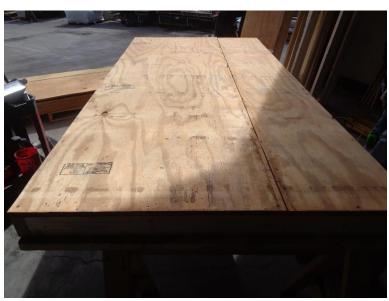
Photo No. 3
Sheathing Installed

5/8 in. thick flamePro plywood was used as the sheathing. This sheathing had a vertical joint on a vertical stud 16 in. from the assemblies centerline. This sheathing was secured to the framing using 2-1/2 in. long 8d nails. These nails were placed 8 in. on center around the perimeter and 12 in. on center in the field of the plywood. The sheathing used for the assembly was verified to have less than an 8% moisture content.

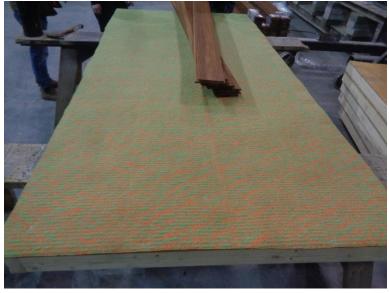
Photo No. 4
Water/Air Barrier Installed

VaproShield® Wrapshield™ RS 3mm water resistive vapor permeable air barrier membrane was used on this assembly. This barrier was secured to the assembly using 5/16 staples on nominal 12 in. centers.

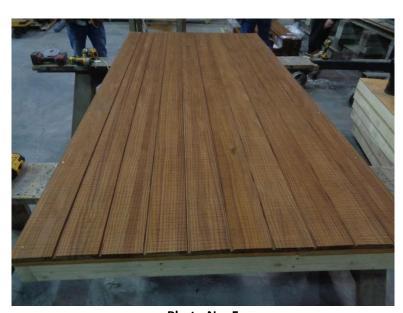
Photo No. 5 Cladding Installed

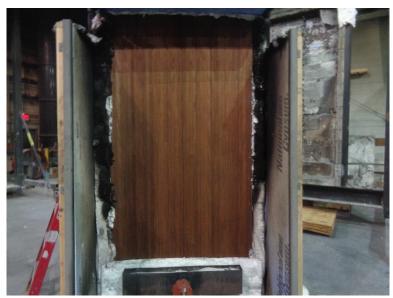
Photo No. 6
Complete Assembly (Exterior Surface)

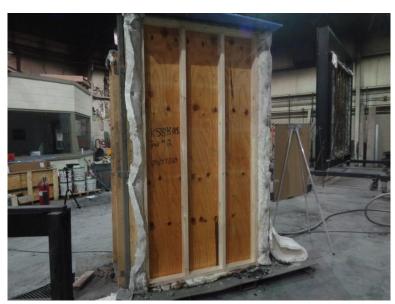
Photo No. 7
Complete Assembly (Interior Surface)

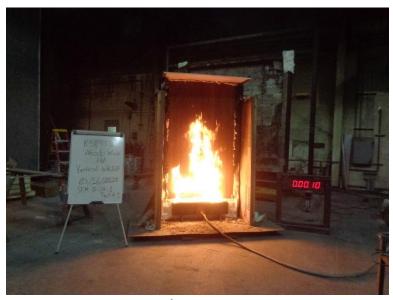
Photo No. 8 Ignition of Burner

The test specimen is installed into the fixture and centered underneath of the combustion collection system. The ignition source for the test is a gas burner with a 4 inch by 39-inch diffusion adapter filled with a minimum 4-inch layer of Ottawa sand. The top surface of the burner through which the gas is applied is positioned 12 inches above the floor. The burner is centered inside of the fixture and is placed in contact with the surface of the specimen. The gas supply to the burner is C.P. grade propane (99 percent purity). The burner is set to produce a gross heat output of 150 ±8 kW for ten minutes. The flow rate is metered throughout the test. The gas burners are controlled with mass flow meters to control the volume of gas to match the heat outputs of the standard. At the end of the ten-minute burn period, the burner is shut off and all instrument readings are stopped. Post-test observations are made for an additional 60 minutes or until all evidence of combustion is no longer visible. The test procedure is repeated to a total of three total tests.

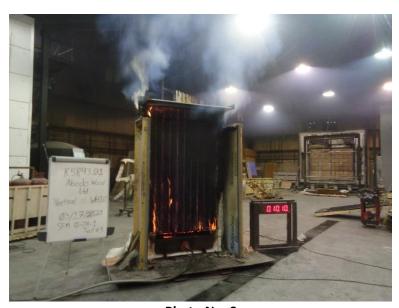
Photo No. 9 Burner Off

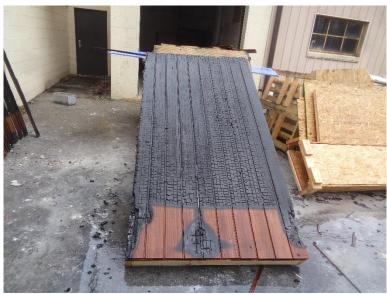
Photo No. 8
Post-test Exterior

TEST REQUIREMENTS	TEST RESULTS	PASS/FAIL
Absence of flame penetration through the wall assembly at any time.	Flame penetration through the assembly was not observed during the full duration of the three tests.	PASS
Absence of evidence of glowing combustion on the interior surface of the assembly at the end of the 70-minute test.	interior surface of the assembly at the	PASS

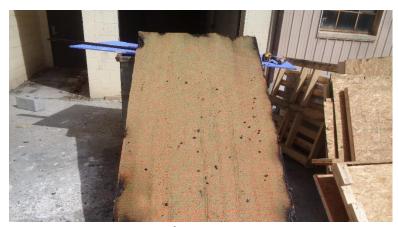
Photo No. 9
Exterior Cladding Removed (Post-Test)
